**Archimedes Screw Turbine Fisheries Assessment.
Phase II: Eels and Kelts.**

Client: Mann Power Consulting Ltd.

March 08

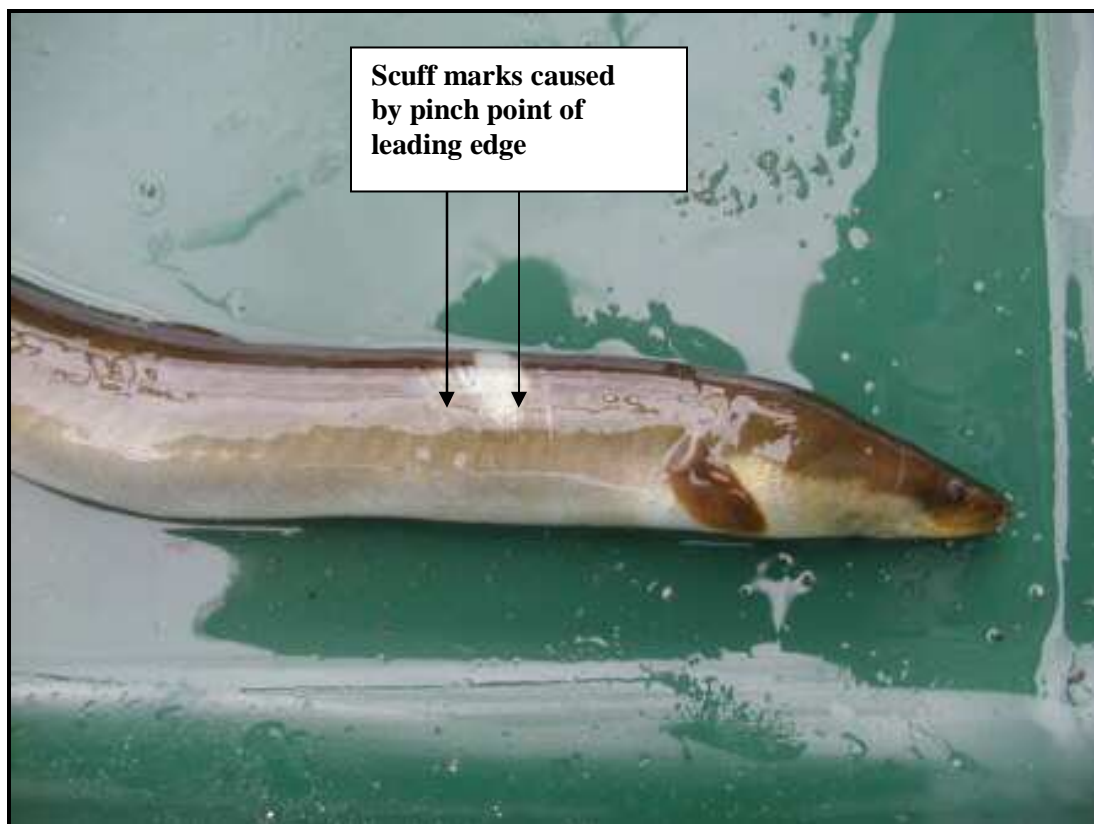
The results are shown in table 1. One out of a total of 12 eels (8%) suffered a severe pinch mark behind the head and a damaged spine, see figure 3. It is unlikely the eel would have survived long term. The scuff marks on the skin suggested that the eel had been trapped by the overhang of the leading edge, shown in figure 4. Placing the eel under the overhang confirmed this, as it fitted exactly into the 20mm gap.

Figure 3. Eel caught in pinch point

Before continuing with the trials, it was decided to modify the edge by cutting it back so it ran within the trough, removing the bevel and pinch point. The modified leading edge is shown in figure 5.

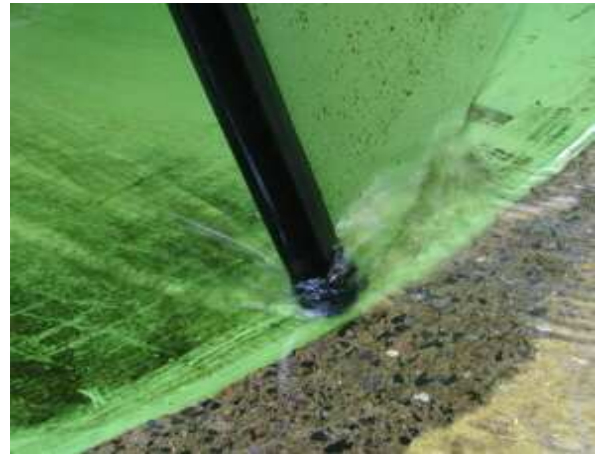
Figure 5. Modified edge

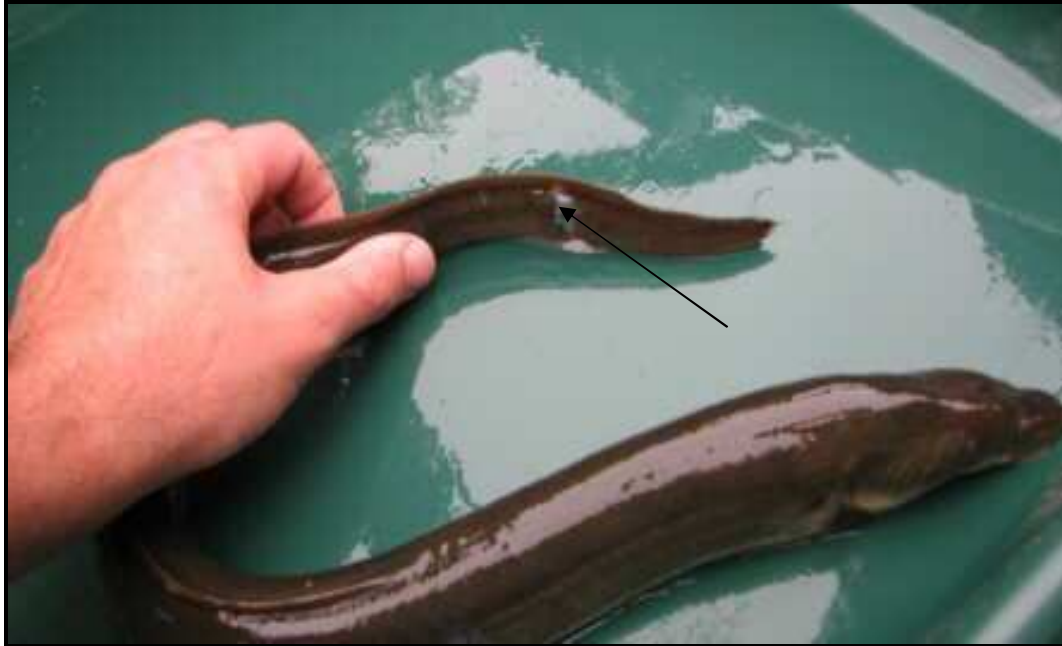
160 passages through the turbine were recorded across a range of speeds as shown in table 2. One eel suffered minor damage in the form of a pinch 5cm from the end of the tail (see figure 8), probably caused by the tail sliding under the 5mm gap between the screw helix and the trough. All the eels were alive and appeared healthy after 7 days in holding tanks. The damaged eel was observed for a further 7 days (14 days in total) after which it was released into the river. It was concluded that the damage to the tail was recoverable and the risk to eels from passing through the screw negligible. Overall the mortality rate was 0%, with less than 1% (0.64%) suffering minimal and recoverable damage.

Figure 8. Eel with pinched tail

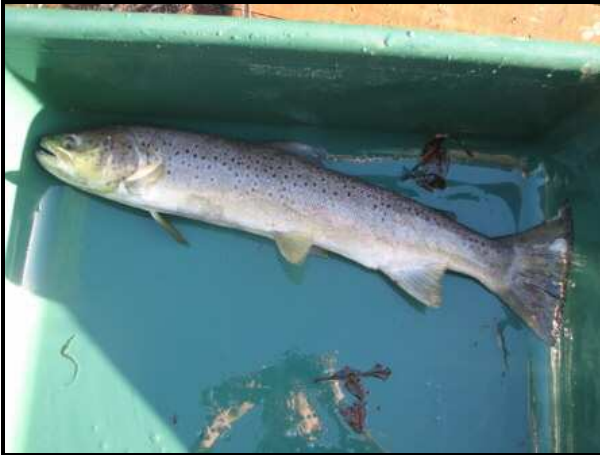
While none of the fish were damaged by passing through the screw, some were in poor condition, with bacterial/fungal lesions and fin rot. This is not unusual, especially for spring run fish that may have been in the river for at least 6-8 months. One of the smaller sea trout kelt and a 77cm salmon kelt are shown in figures 13 and 14 below.

Figure 13. Sea trout kelt.

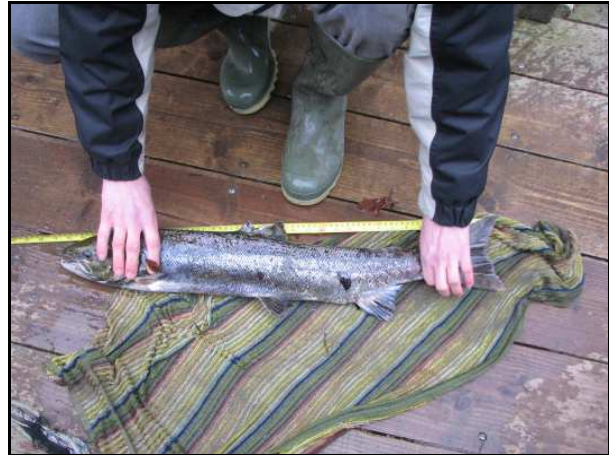
Figure 14. Salmon kelt

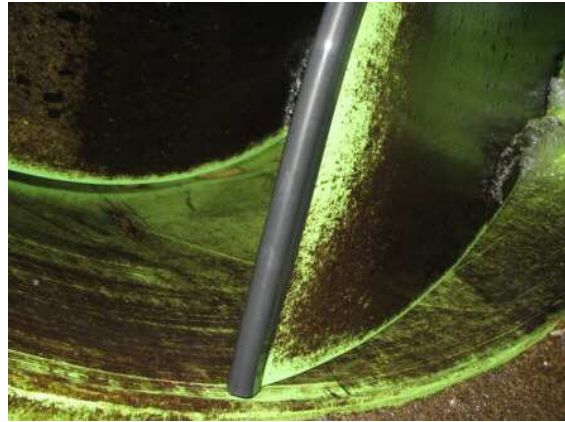
The bumpers fitted to the leading edge were assessed after 8 months of continuous operation. They were in perfect condition (see appendix) and could be expected to last for 5-10 years.

After 8 months of operation

The leading edge must be modified by removing the bevel and any overhang of the trough. Extruded rubber profiles (fish bumpers) should also be fitted to protect larger fish in particular. While the bumpers are extremely durable, they should be inspected during routine maintenance, every 6 to 12 months.
