## **Fish Monitoring and Live Fish Trials. Archimedes Screw Turbine, River Dart**

**Phase 1 Report: Live fish trials, smolts, leading edge assessment,  
disorientation study, outflow monitoring.**

**Client: Mann Power Consulting Ltd.**

**Project: River Dart (Ashburton)**

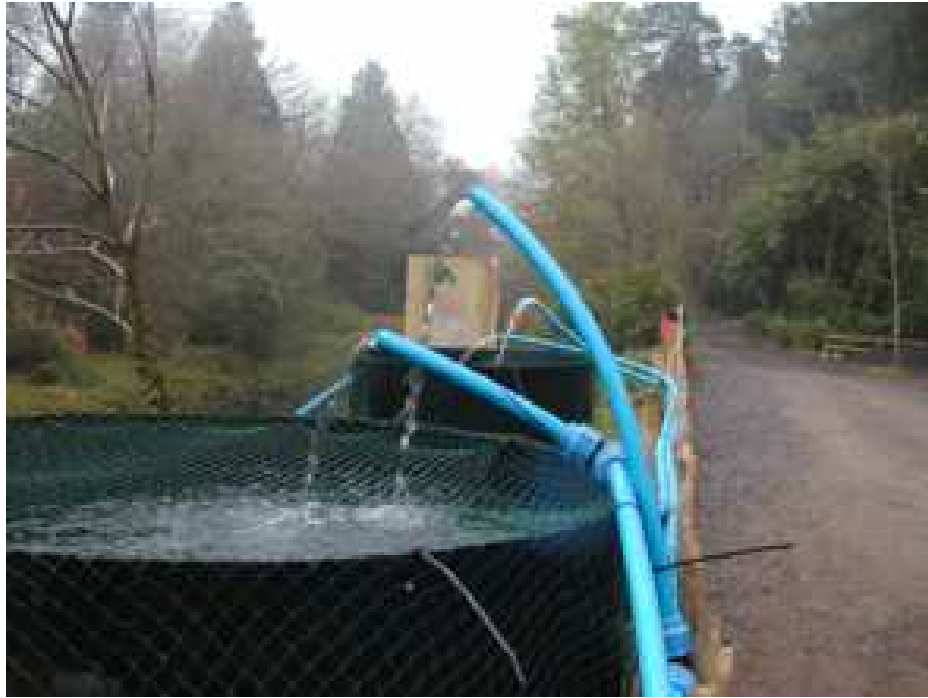
**Figure 5. 1000 litre fish holding tanks.**

Brown trout were sourced from Torr Fish Farm on Exmoor. These were reared in water with similar pH to the River Dart. Fish were kept in large 1000 litre tanks (see fig 5), with water pumped through continuously from the leat at the rate of 40 litres per minute. Two pumps were used to ensure that in the event of one failing, the fish would still receive enough water.

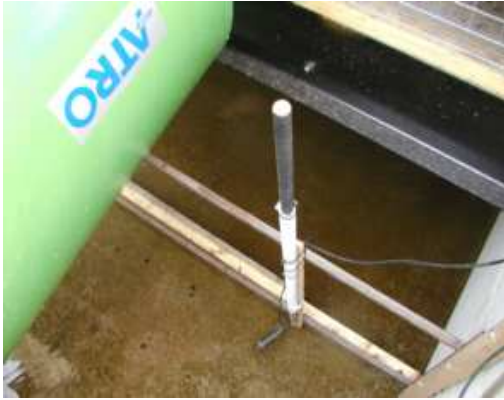
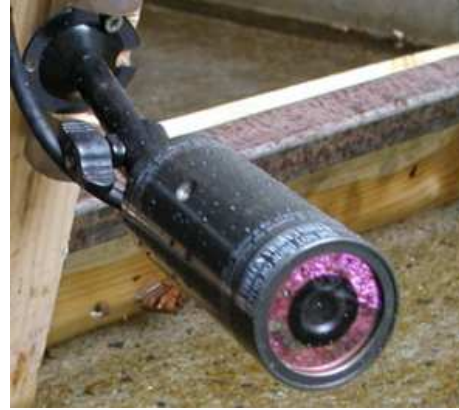
Fish were monitored using infra red sensitive under water cameras, as shown in figure 8 and 9 below. These record in colour during the day and switch to black and white at night. Infra red LED's built into the cameras provide a light source for night viewing, although this was boosted with additional underwater IR lights.

- Before the intake and looking directly onto the leading edge to view fish passing into the first chamber.
- Within the screw to assess if fish are exposed to high levels of turbulence that may cause disorientation.
- In the outflow box to monitor fish behaviour as they are issued from the bottom of the turbine.
- In the outflow channel and outflow box to monitor sea trout and salmon as they approach the turbine from the outflow channel.

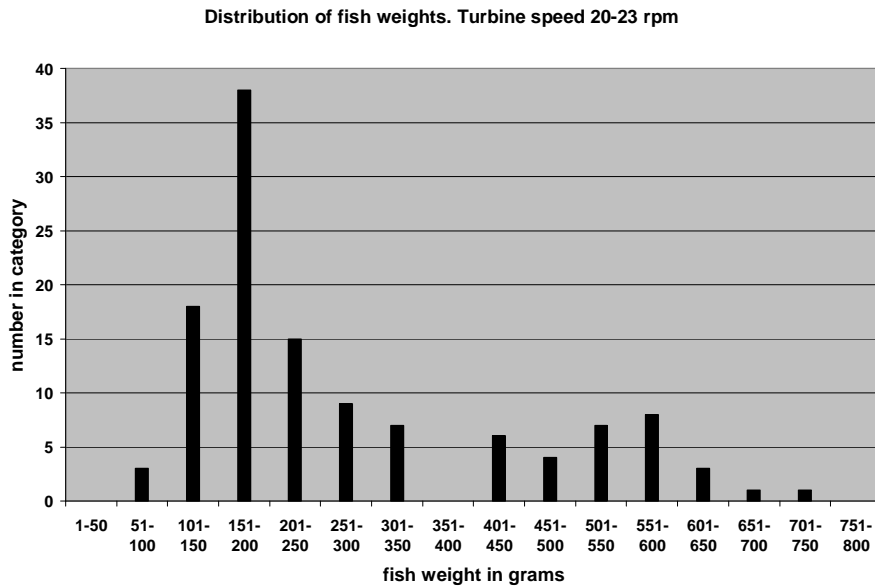
132 fish passed through the device at this speed. The weight and length distributions are shown in figure 11 and 12. Four fish suffered limited scale loss of 5-10% (category 3). These were 17cm, 19cm, 22cm and 24 cm. The number of fish with scale loss was very low and almost the same as the net component, indicating that passage through the turbine caused no damage.

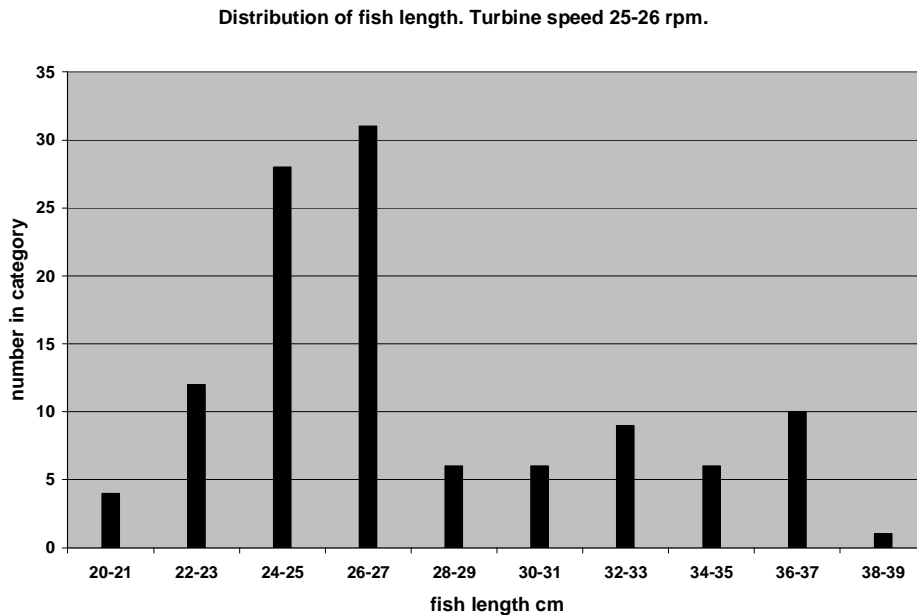
120 fish passed through at this speed. The weight and length distributions are shown in figures 13 and 14. Three fish suffered limited scale loss of 5-10% (category 3), 2.5% overall. They were 23cm, 23cm and 25 cm. Again the percentage was within the net damage component and therefore it was unlikely any scale loss was caused by the turbine.

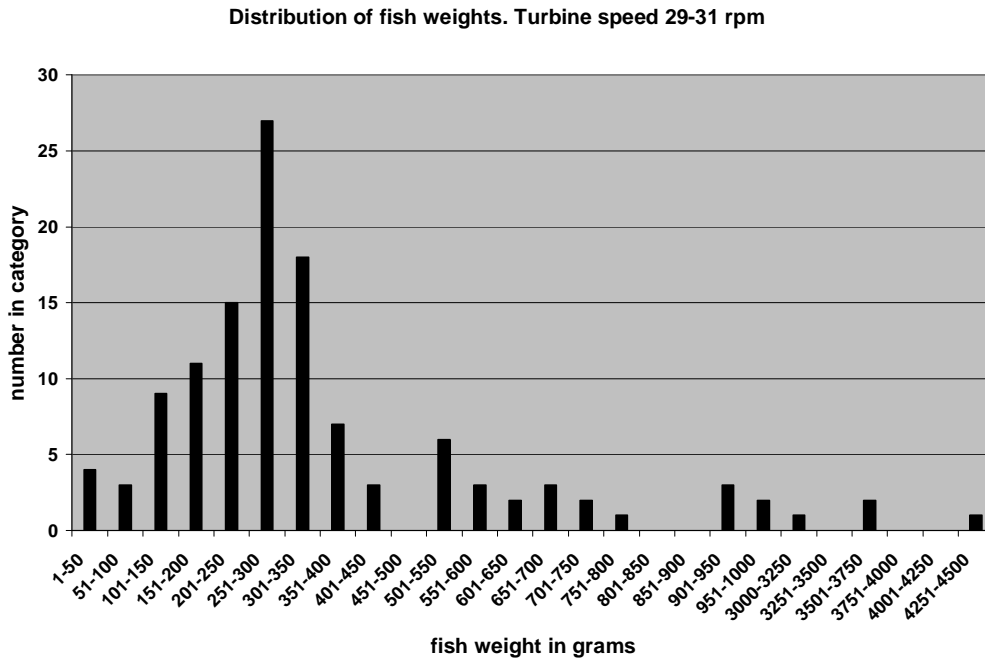
125 fish passed through the turbine. The weight and length distributions are shown in figures 15 and 16. Four fish suffered minor scale loss of 5-10% (category 3). These were 18cm, 20 cm, 22 cm and 25 cm. This gave an overall value of 3.02% and was almost within the net component.

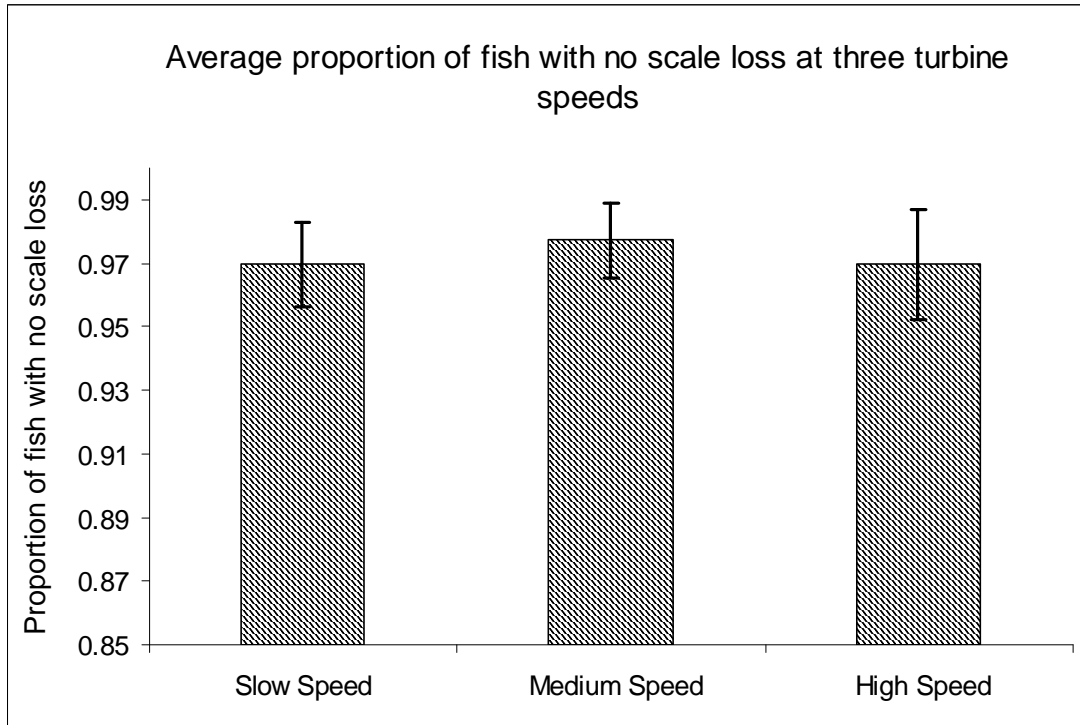
**Figure 17.**

A Kruskal-Wallis test was used to compare the results from each turbine speed. (H=0.22, df=1, p=0.895). The high P value showed that there was no significant difference between slow, medium and high speed.

The results from trials at 3 speeds are compared in figure 17 above. The error bars are +/- one standard error of the mean.

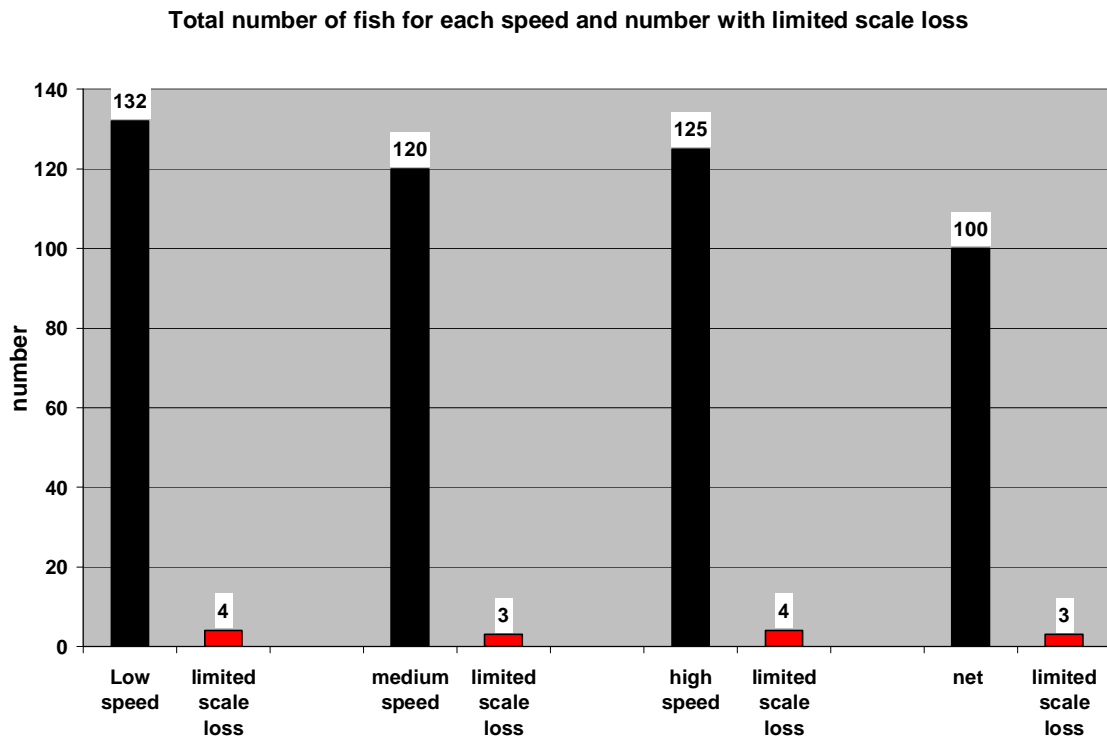
Figure 18.

Figure 18 compares the number of fish that sustained limited scale loss (category 3) across the 3 different speeds with the number in category 3 from the net test. It is evident from this that any scale loss sustained is within the net damage component and that passage through the screw caused no damage at all.

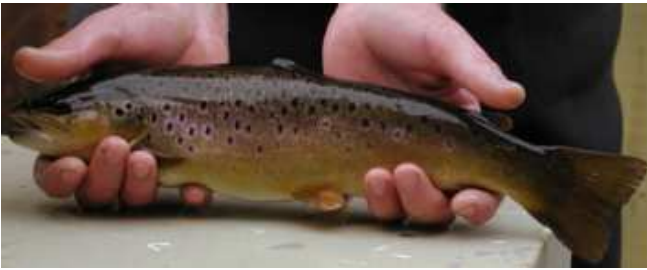
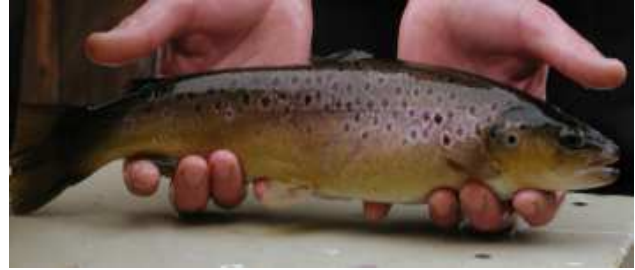
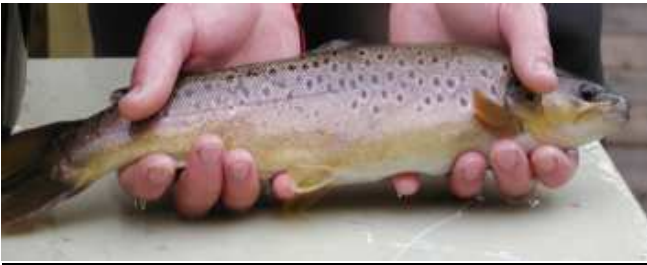
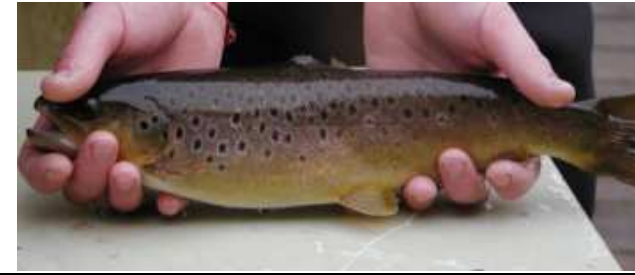
**Figure 19. The same fish before and after it has passed through the turbine.**

An example of a fish before and after passing through is shown in Figure 19 below. A fish showing minor scale loss, typical of those in category 3 is shown in Fig. 20.

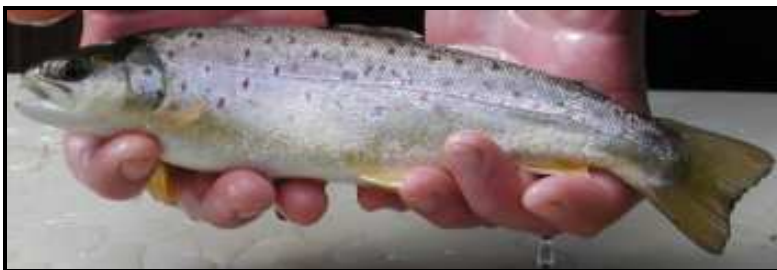
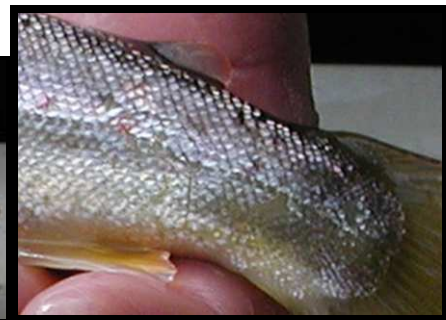
**Figure 20 A fish with category 3 damage showing limited scale loss towards the tail.**

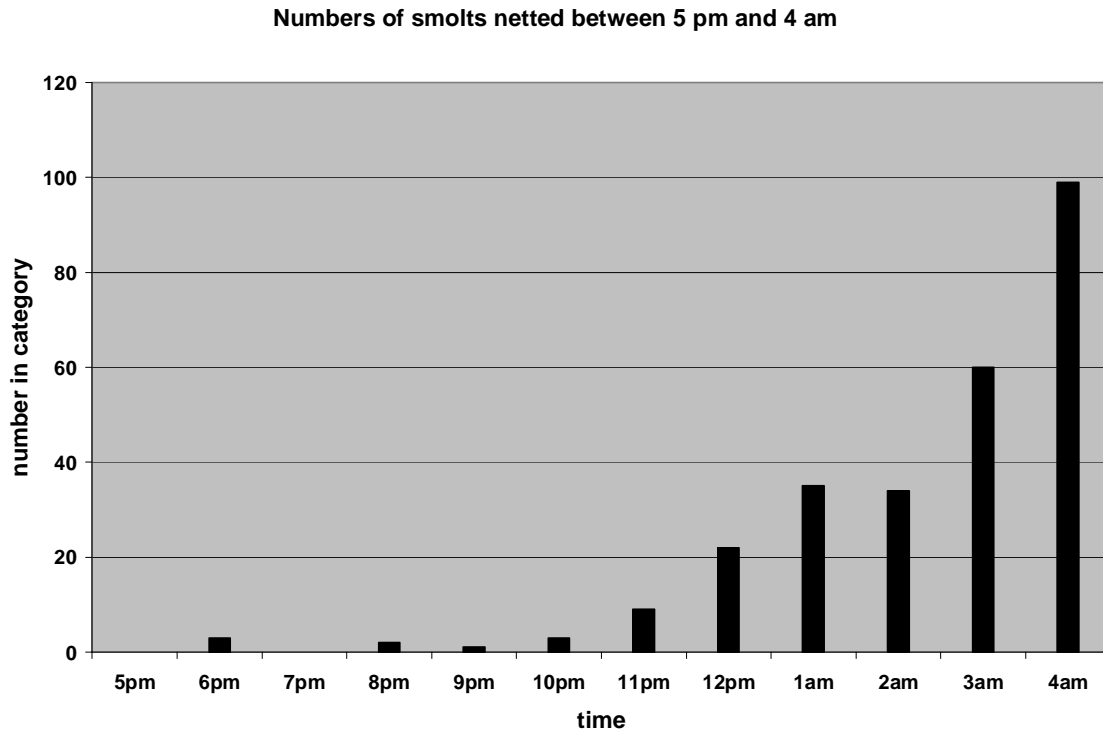
**Figure 21**

Smolts were trapped throughout the evening and night, however, the majority of fish passed through between 2 am and 4 am as shown in Figure 21 below.

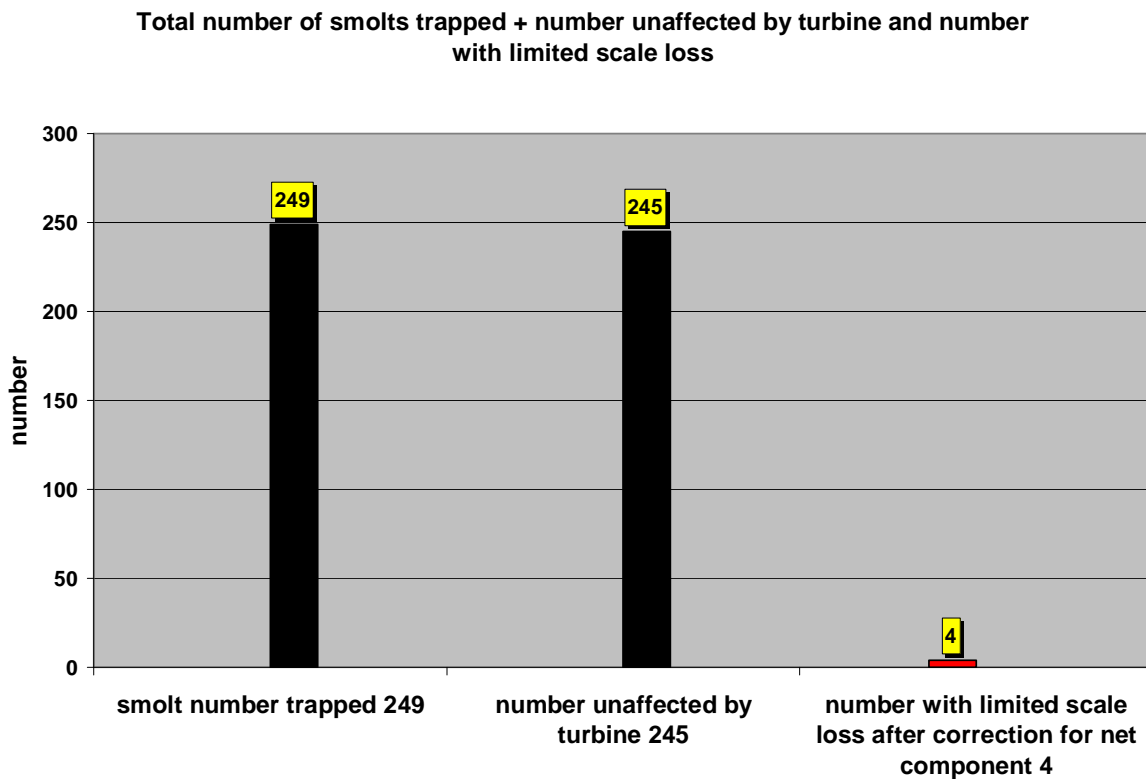
**Figure 23**

Figure 23 shows the total number of smolts trapped, the number without any damage and the number with limited scale loss after correcting for the net component.

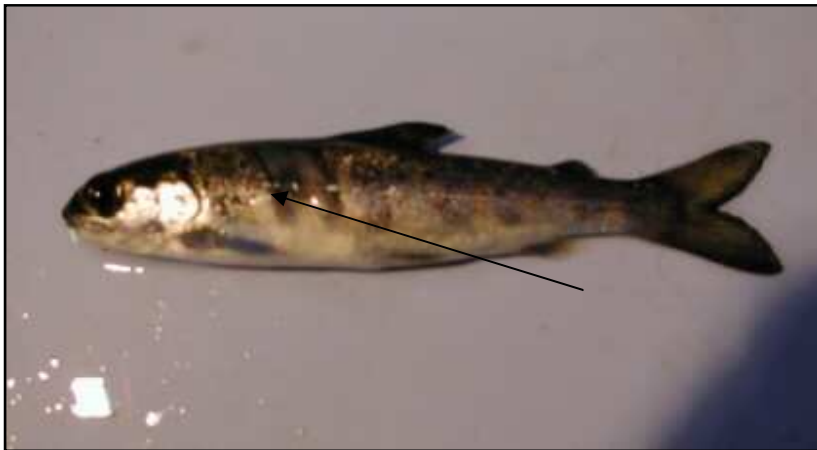
**Figure 25**

Figure 25 clearly shows the diagonal mark across the flank of the fish, corresponding to the width of the leading edge.

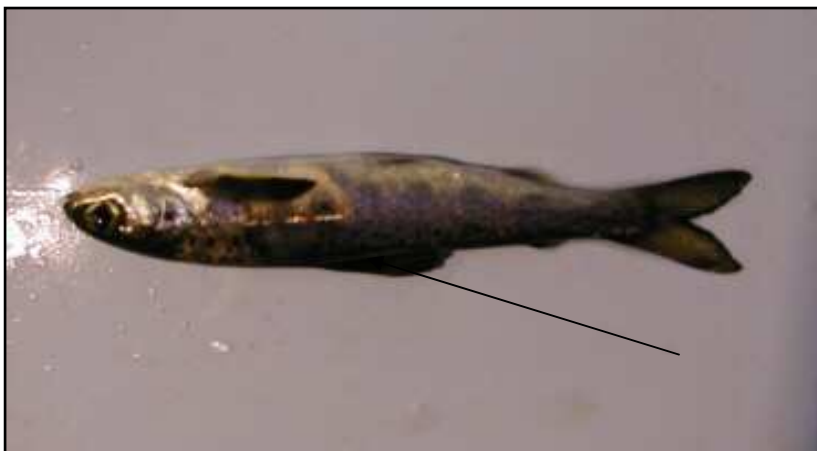
**Figure 26**

Figure 26 shows the scale loss resulting from the fish being scraped along the base of the turbine.
