**Archimedes Screw Turbine Fisheries Assessment.
Phase II: Eels and Kelts.**

Client: Mann Power Consulting Ltd.

March 08

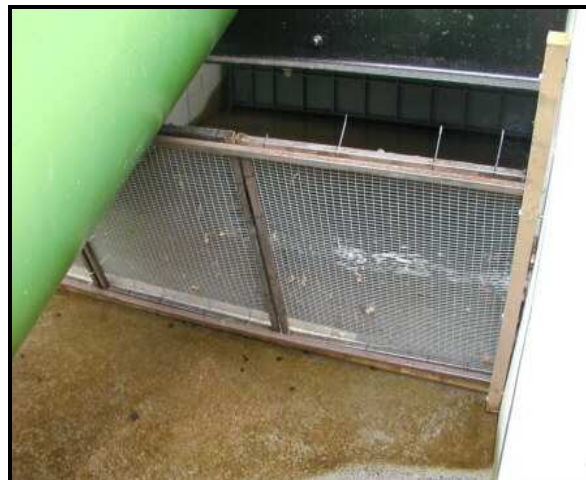
Figure 2

They were introduced approximately 1m behind the leading edge via a 110mm diameter fish pipe referred to in Phase 1 (See Phase 1 DVD). This ensured eels entered the turbine near the base, maximising exposure to the leading edge and hence the risk of injury. A screen of 10mm x 10mm galvanized steel mesh was installed in the forebay tank to prevent them escaping into the leat, see figure 2. A second screen at the outflow trapped the eels after they had passed through.

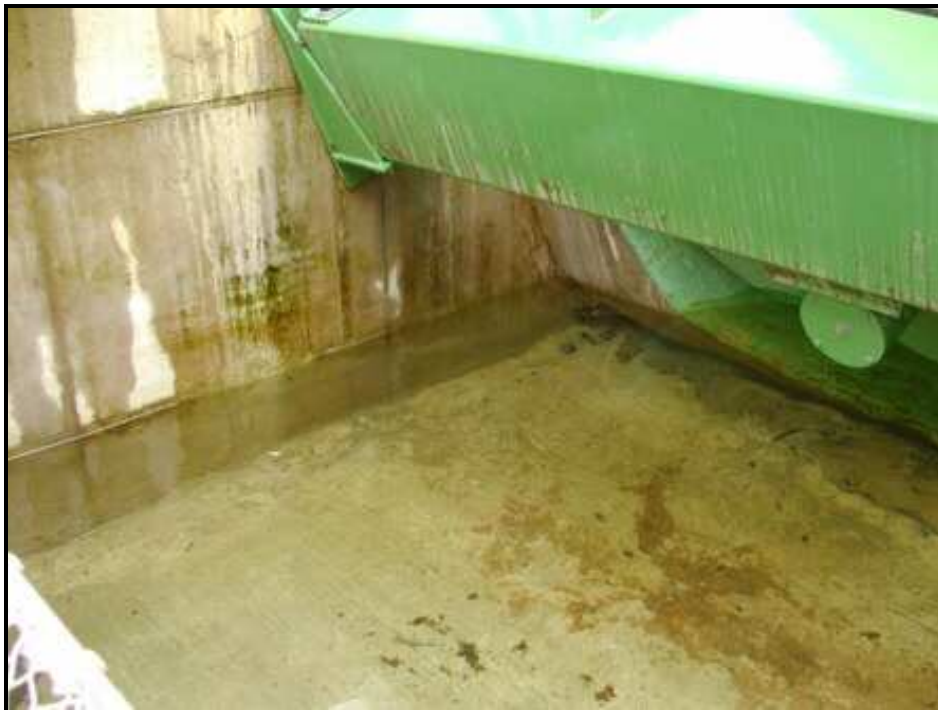
Figure 11. Trap at the outflow box

A grid of 50mm x 50mm weld mesh formed a holding area to trap fish in the outflow box, see figure 11. The trap was checked every morning and evening. Fish were assessed for turbine induced damage, such as scale loss, strike marks from the leading edge and haematoma. They were photographed, weights and lengths recorded and then released.

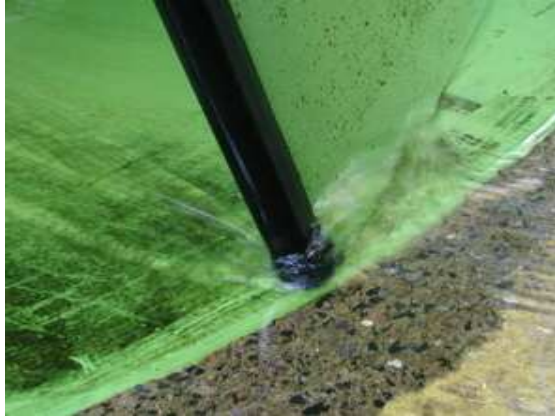
The bumpers fitted to the leading edge were assessed after 8 months of continuous operation. They were in perfect condition (see appendix) and could be expected to last for 5-10 years.

Rubber extrusion (fish bumper) after fitting
